HITLER'S TANKS

GERMAN PANZERS OF WORLD WAR II

EDITED BY
CHRIS McNAB

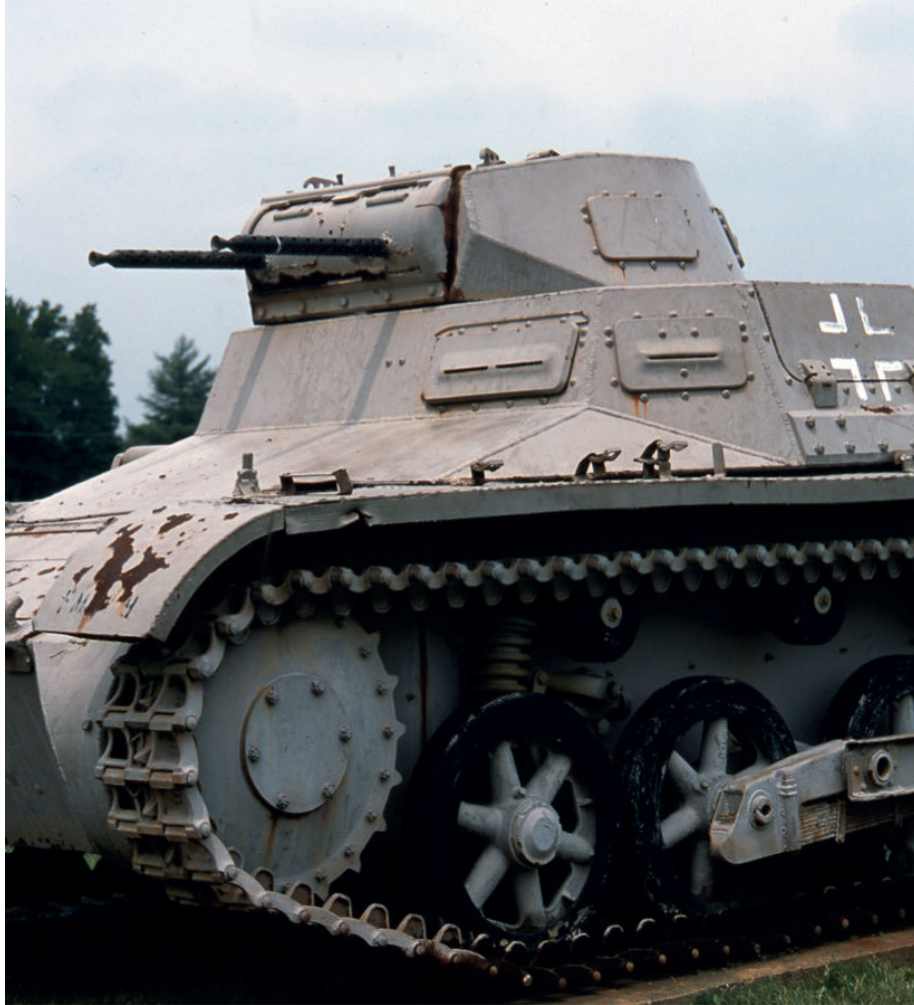
This captured German PzKpfw I Ausf B is on display in the United States. The two 7.92mm MG 13 machine guns could be fired either together or independently. (AirSeaLand/Cody)

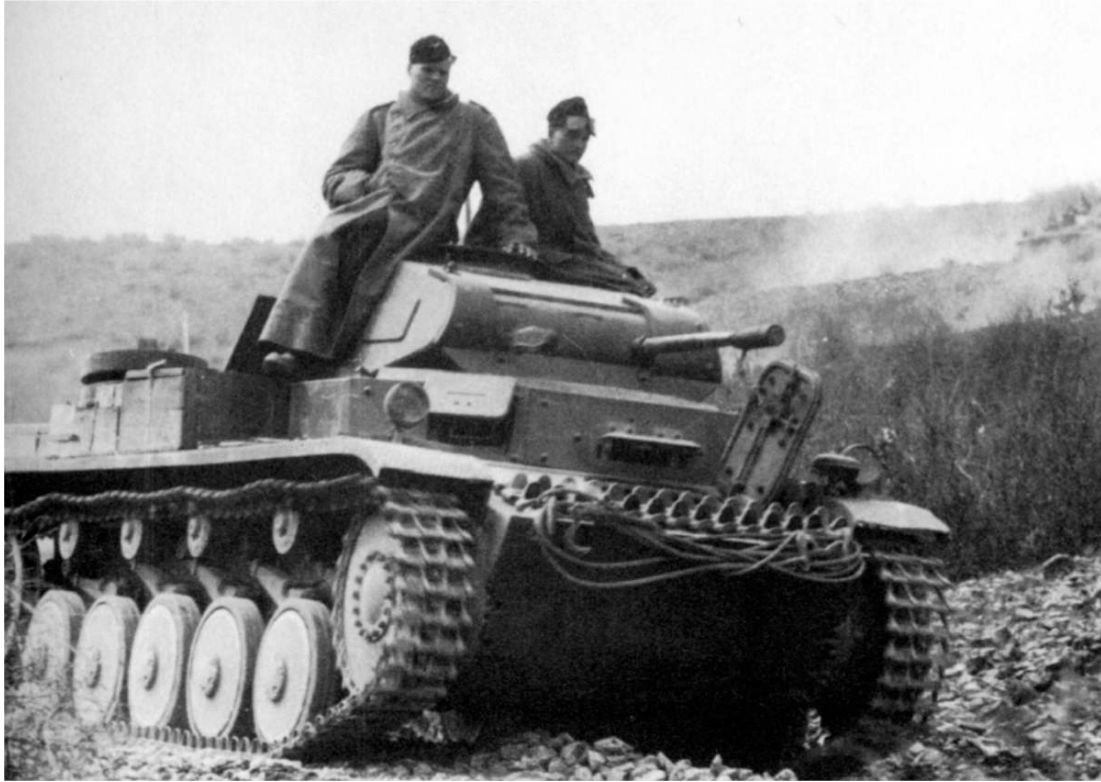
A PzKpfw II in the Balkans. The vehicle's good cross-country performance meant it could use movement and terrain to avoid being targeted; its leaf-spring suspension was suited to its light weight and proved to be simple, effective and easy to repair.

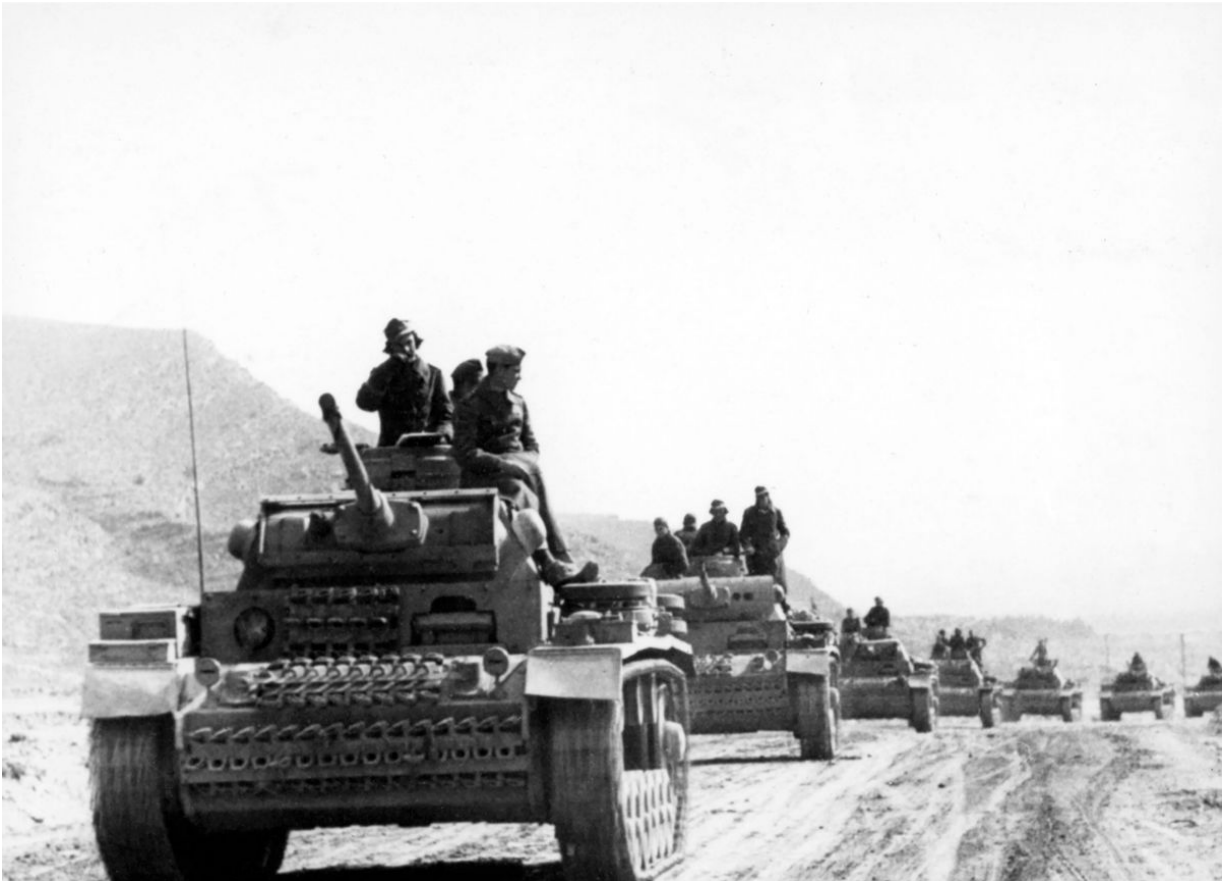
PzKpfw IIIs in Tunisia in 1942. The spare tracks links were not just for track breakdowns, but also provided a form of additional armour, particularly against shaped-charge rounds.

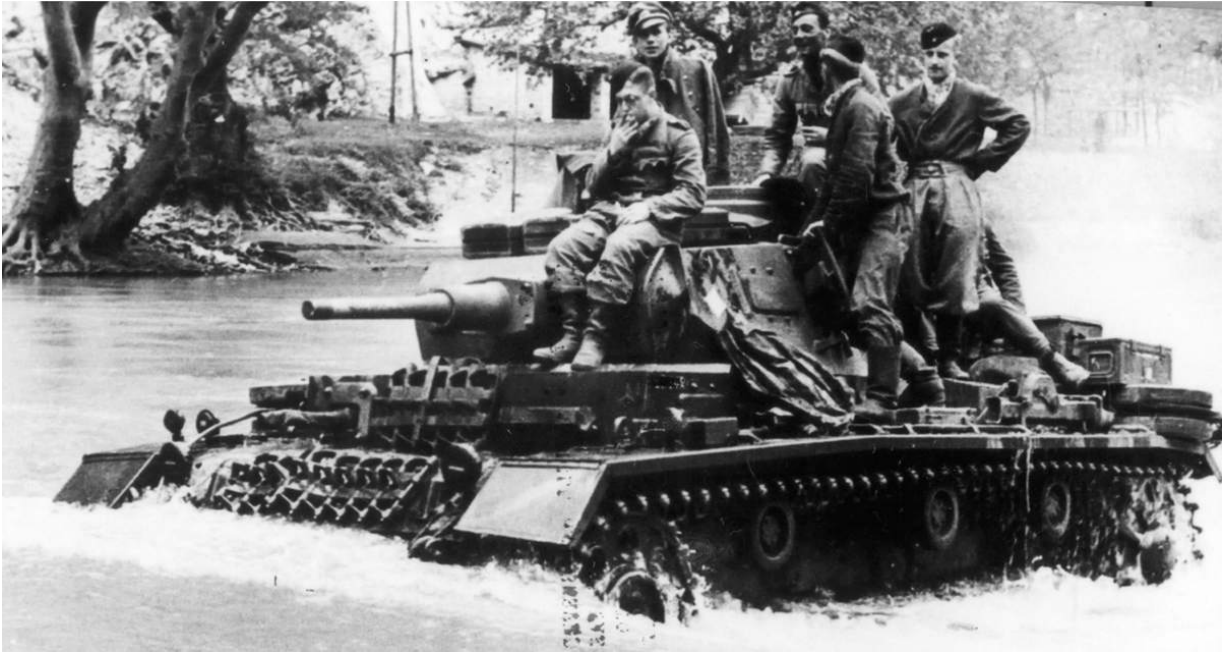
A PzKpfw III in Greece, 1941. The PzKpfw III had an advanced suspension that provided a smoother ride due to greater road wheel travel from its torsion-bar suspension.
(AirSeaLand/Cody)

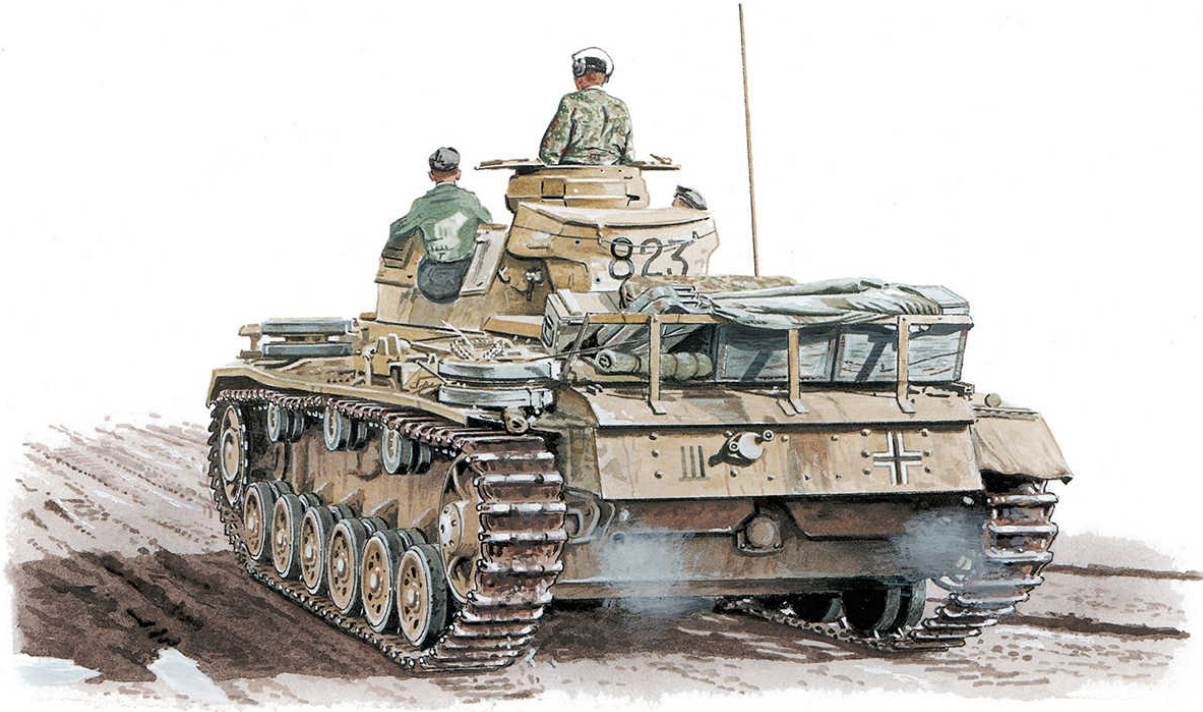
2) PzKpfw III Ausf L, 3. SS-Panzer-Division Totenkopf; Kursk, July 1943. Note the large strap-iron stowage rack welded across the rear hull; these were common, and as they were strictly a unit modification they took many varying forms. (David E. Smith © Osprey Publishing)

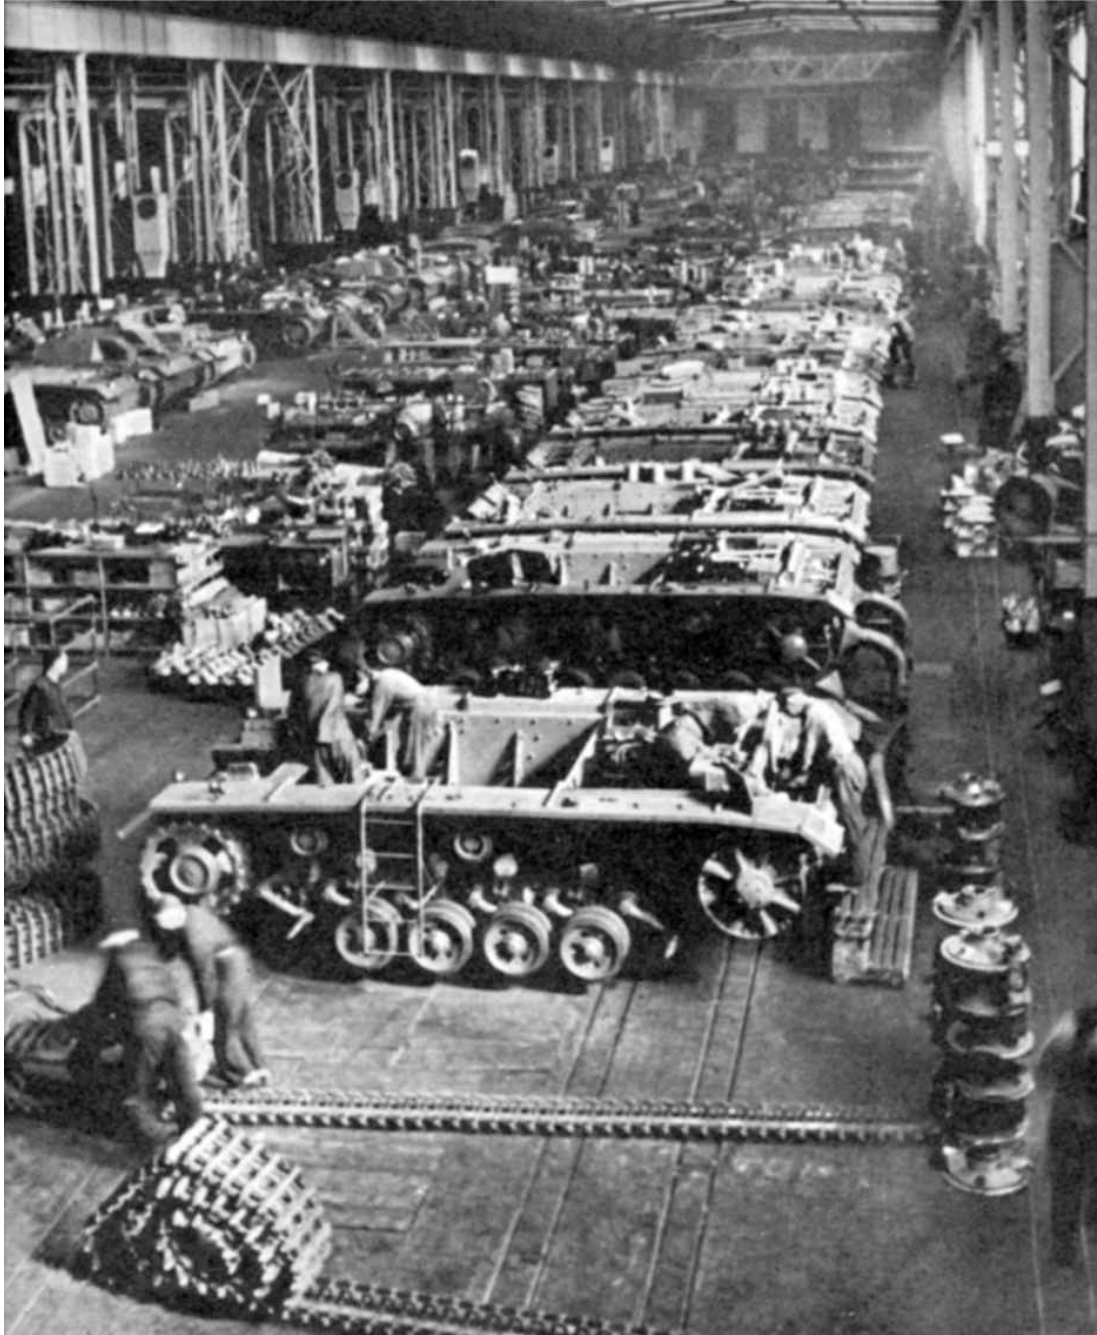
A PzKpfw III production line in 1941, showing particularly the track rolls and two exposed torsion bar suspension units for the road wheels. The PzKpfw III chassis served as the basis for a number of specialized AFVs. (AirSeaLand/Cody)

The Ausf E, which appeared in 1939, finally overcame the difficulties that had been experienced with the suspension. A robust torsion bar system was adopted, employing six small road wheels. The redesign of the running gear also incorporated a new disc idler, and the position of the three return rollers was slightly altered. This Mark was driven by the 300hp 12-cylinder Maybach HL 120 TR engine, and the manual gearbox employed on the earlier models was replaced by the Maybach Variorex pre-selector box which provided ten forward and one reverse gears. Although the vehicle's weight was now 20 tonnes, the more powerful engine produced a top speed of 25mph.

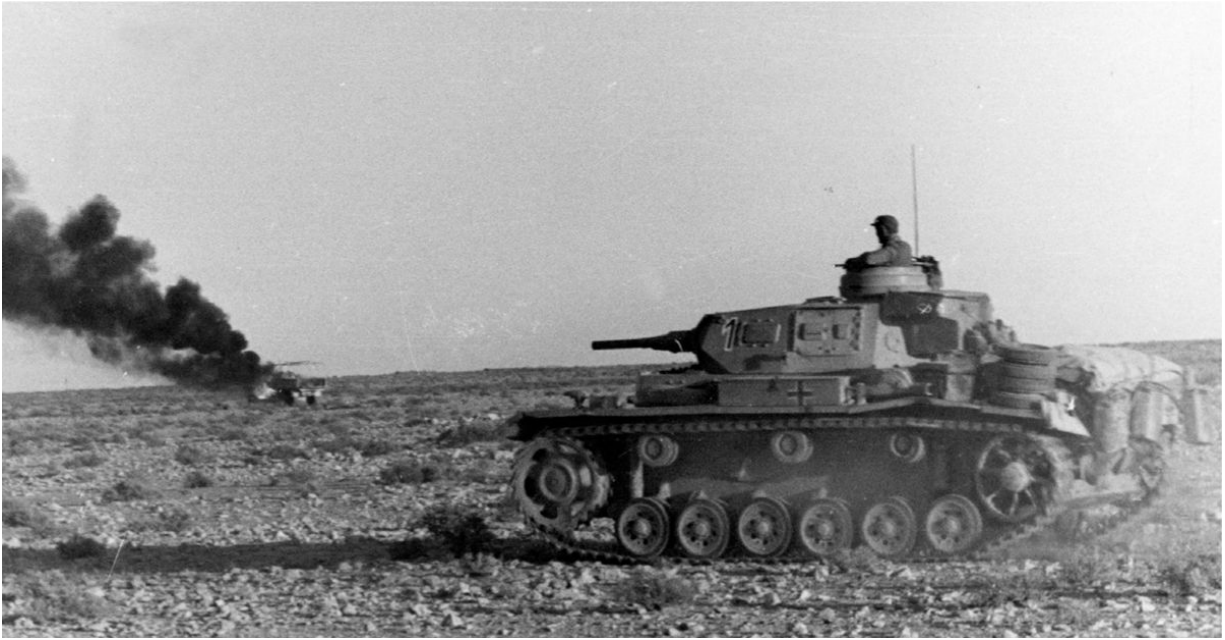
A PzKpfw III Ausf G in North Africa, 1941. Later production models of this type were armed with the 5cm KwK 38 L/42 main gun, which had an effective range of up to 2,000m.
(AirSeaLand/Cody)

Ausf G, which first appeared in October 1940, presented little external difference from its immediate predecessor, but possessed an improved commander's cupola. The first few vehicles mounted the 3.7cm main armament, but thereafter the L/42 5cm gun was fitted as standard. The Ausf G was modified for service in North Africa by the provision of larger radiators and an additional air filter made from felt.

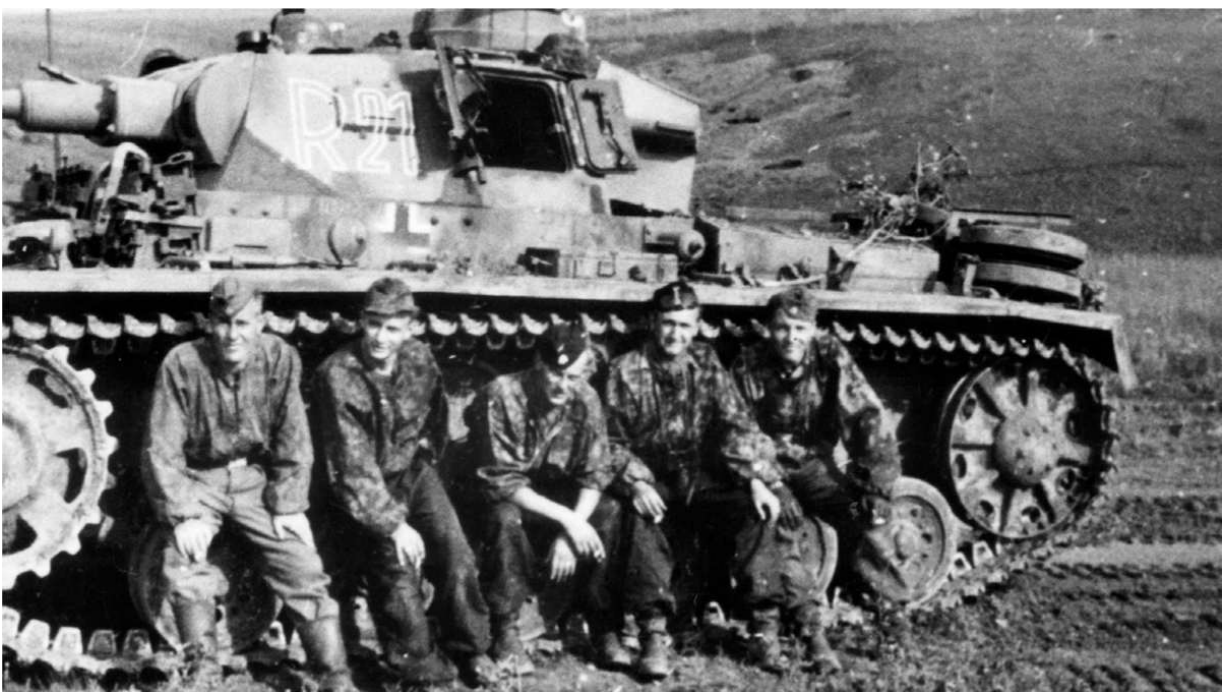
This PzKpfw III Ausf G, serving on the Eastern Front in July 1943, is crewed by men of the infamous Das Reich Division. Production of the PzKpfw III Ausf G with the 5cm gun was planned to begin in June 1940, but the first tanks were not accepted until July and were not in service use until August 1940. (AirSeaLand/Cody)

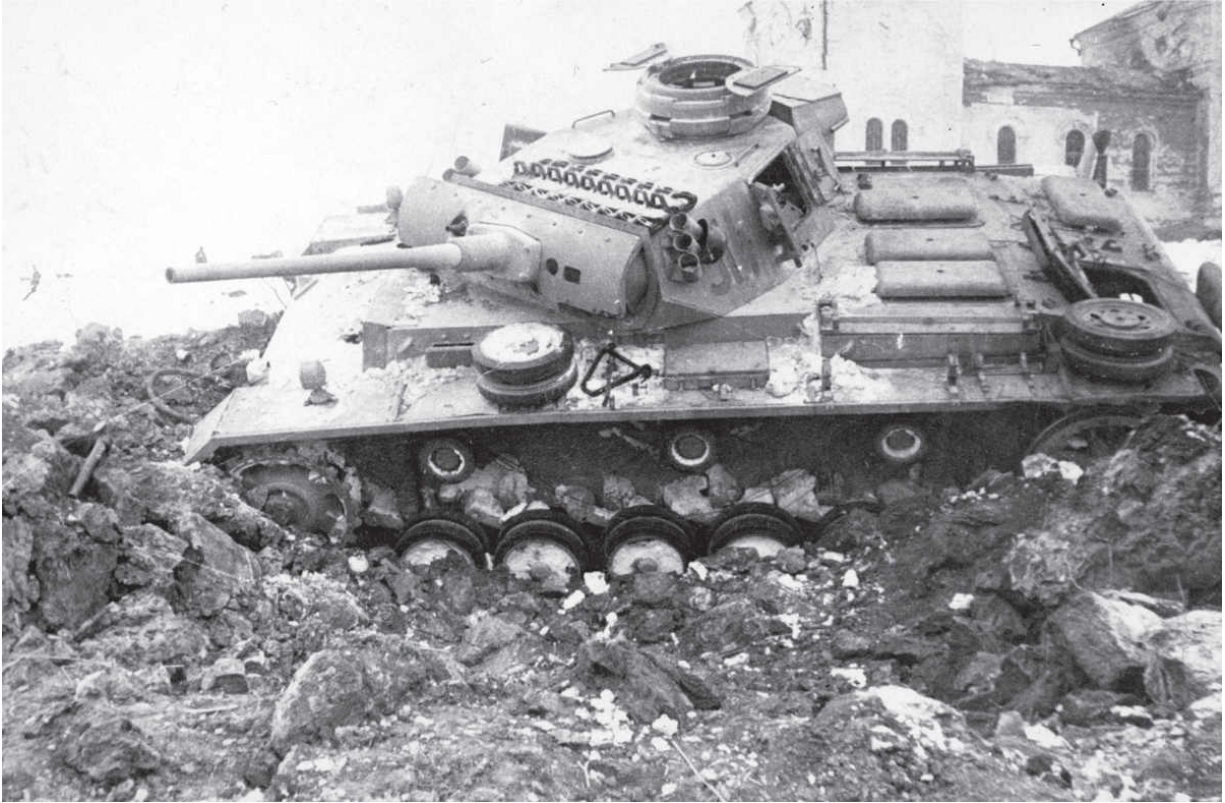
A knocked-out PzKpfw III Ausf M, distinguished by features such as the visible bank of smoke dischargers. It also featured a self-sealing exhaust for deep wading operations.
(AirSeaLand/Cody)

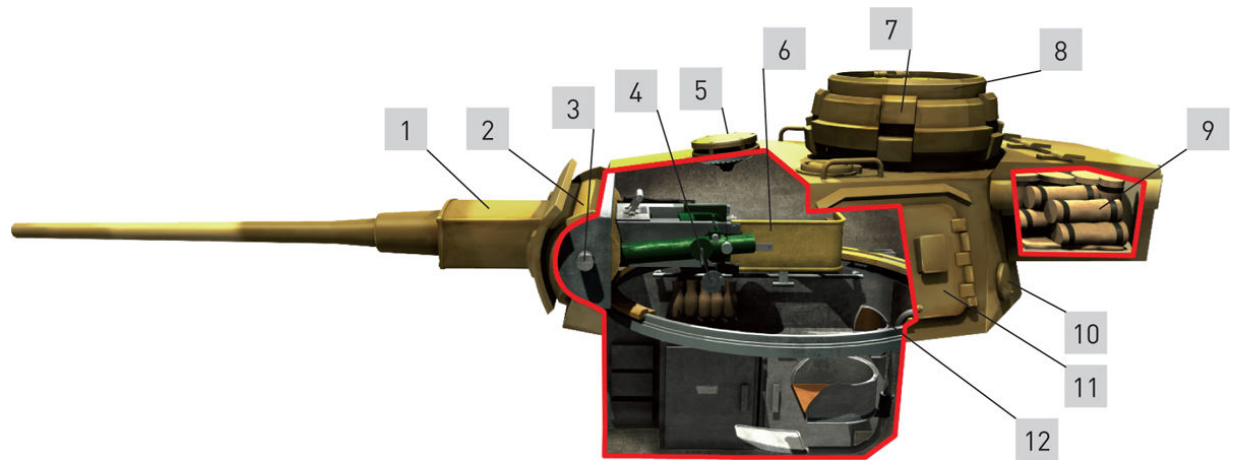
PZKPFW III TURRET

- 1.** 5cm KwK 39 L/60 gun
- 2.** Gun mantlet with add-on spaced armour shield
- 3.** 5cm gun trunnion
- 4.** Gun traverse handwheel
- 5.** Turret air ventilator
- 6.** Gun shield
- 7.** Cupola vision blocks (× 5)
- 8.** Commander's cupola with hatch
- 9.** Add-on equipment bin
- 10.** Pistol port
- 11.** Turret escape hatch with pistol port
- 12.** Commander's seat and bracket

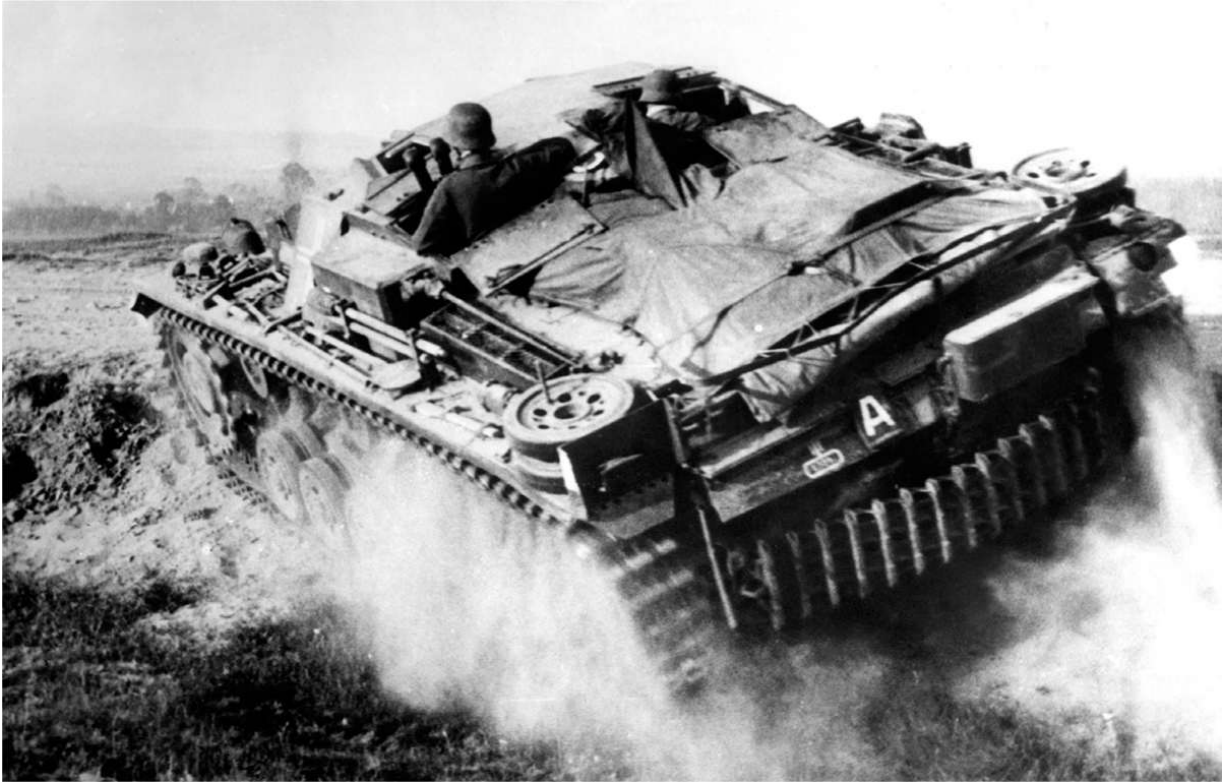
A StuG III Ausf B makes fast progress cross-country during training in Poland. The Ausf B was initially fitted with the L/24 7.5cm howitzer, but later acquired longer-barrelled guns with better velocities. (AirSeaLand/Cody)

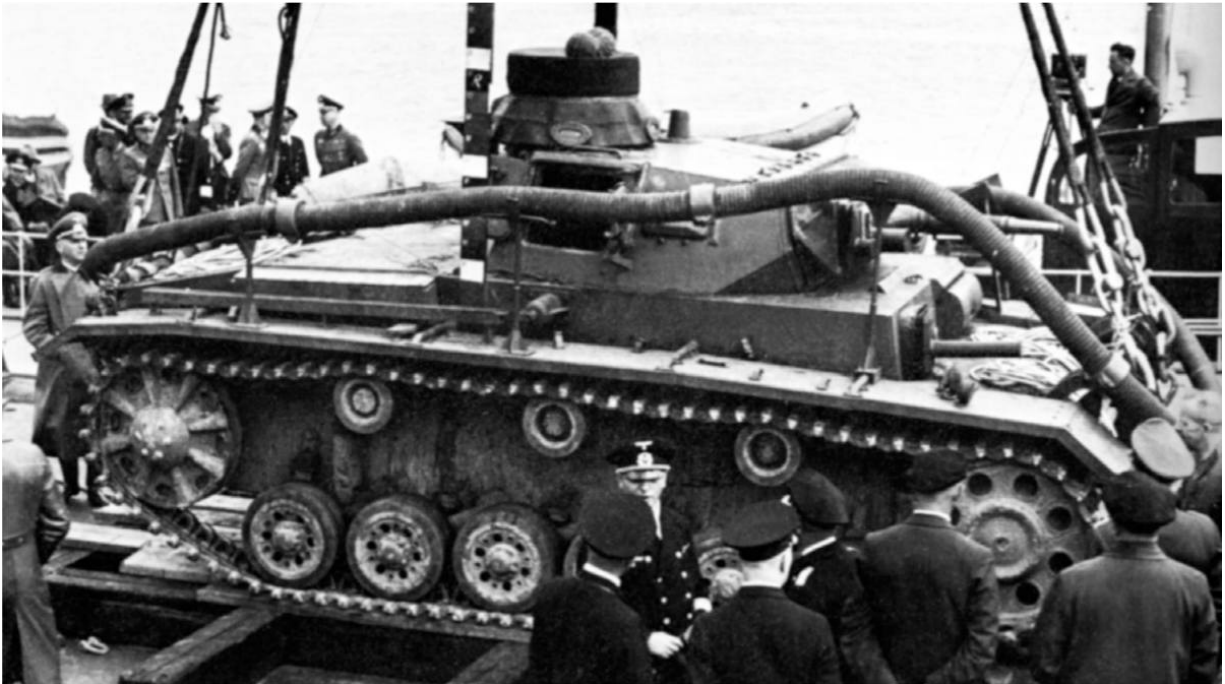
A demonstration of the unusual PzKpfw III Tauchpanzer (diving tank). Air to the inflatable parts of the system came from the 18m-long flexible hose, visible here running around the turret. All being well (which it often wasn't), the vehicle could be submerged for up to 20 minutes. (AirSeaLand/Cody)

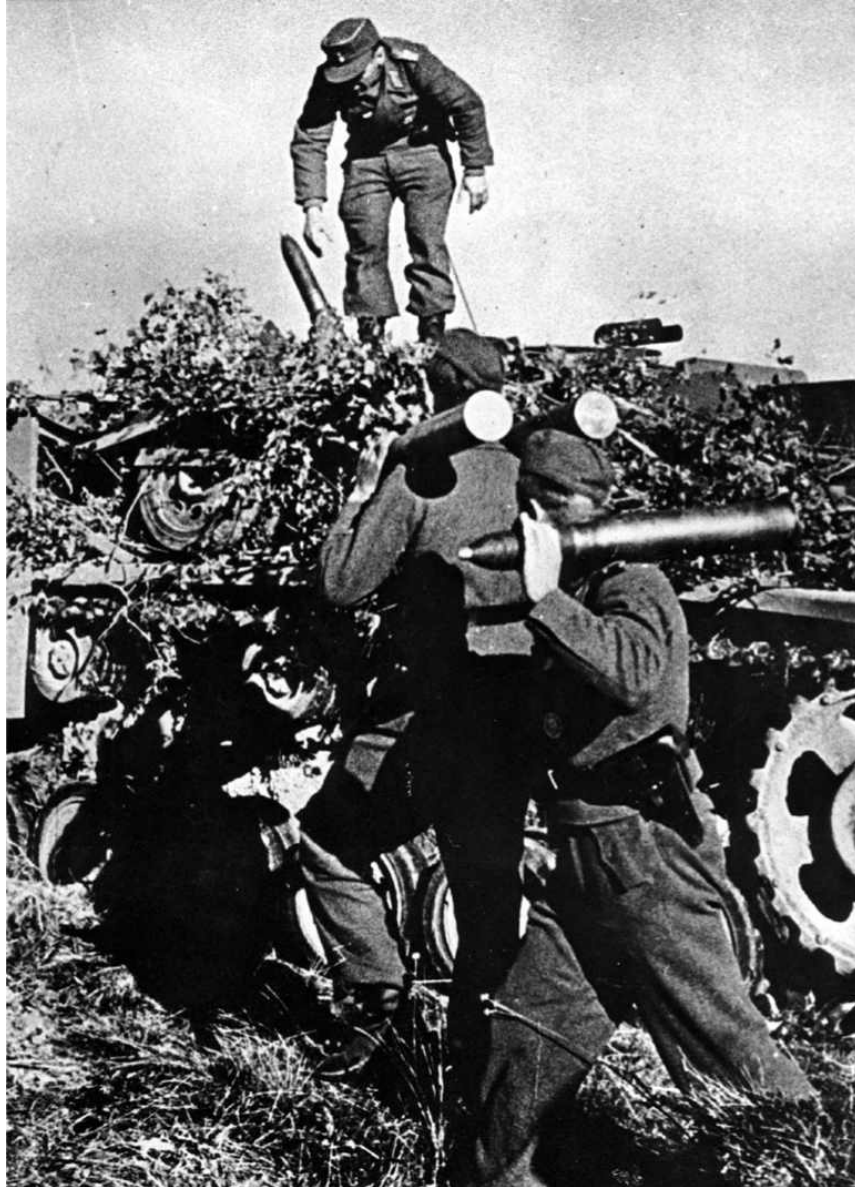
On the Eastern Front, the crew of a StuG III quickly take on more 7.5cm ammunition. Ammunition capacity was about 55 rounds, depending on the model. (AirSeaLand/Cody)

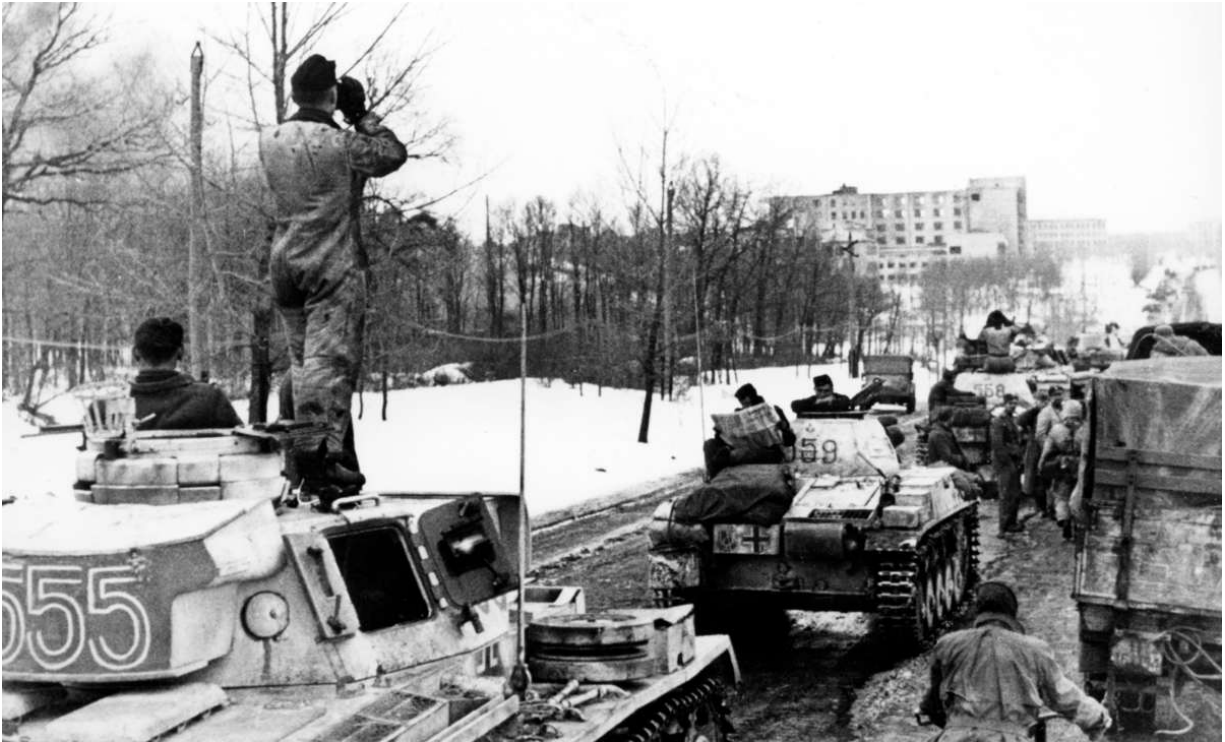
A formation of PzKpfw IIIs prepare to move through Kharkov. The hatch just behind the commander's cupola provided access to a space for storing crew belongings.
(AirSeaLand/Cody)

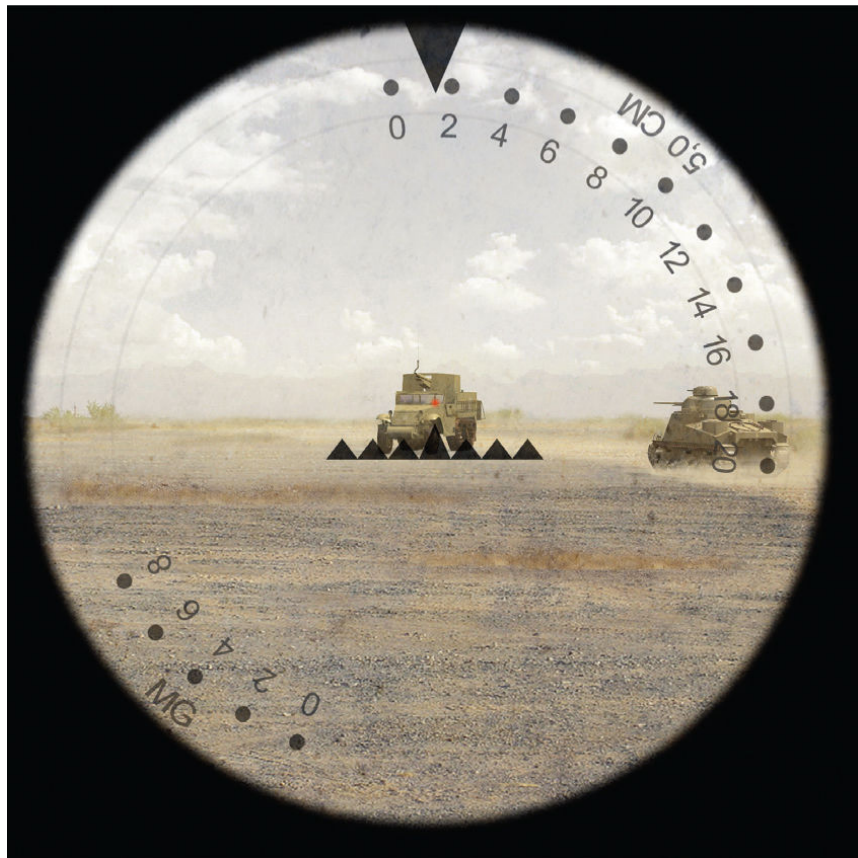
PZKPFW III GUN SIGHT

The sighting telescope was more complicated than its British counterpart, which employed a simple graticule pattern and contained two movable plates. The first or range plate rotated about its own axis, the main armament and machine-gun scales being marked on opposing quadrants; the 5cm scale was marked from 0 to 2,000m, and the machine-gun scale from 0 to 800m. The second or sighting plate moved in a vertical plane and contained the sighting and aim-off markings. The two plates moved simultaneously, the sighting plate rising or falling as the range plate turned. To engage at a selected range, the range wheel was turned until the required marking was opposite the pointer at the top of the sight, and the sighting mark laid onto the target by the traverse and elevation controls.

Range 200m: the 5cm gun has been fired and the tracer is en route to the half-track driver's compartment.

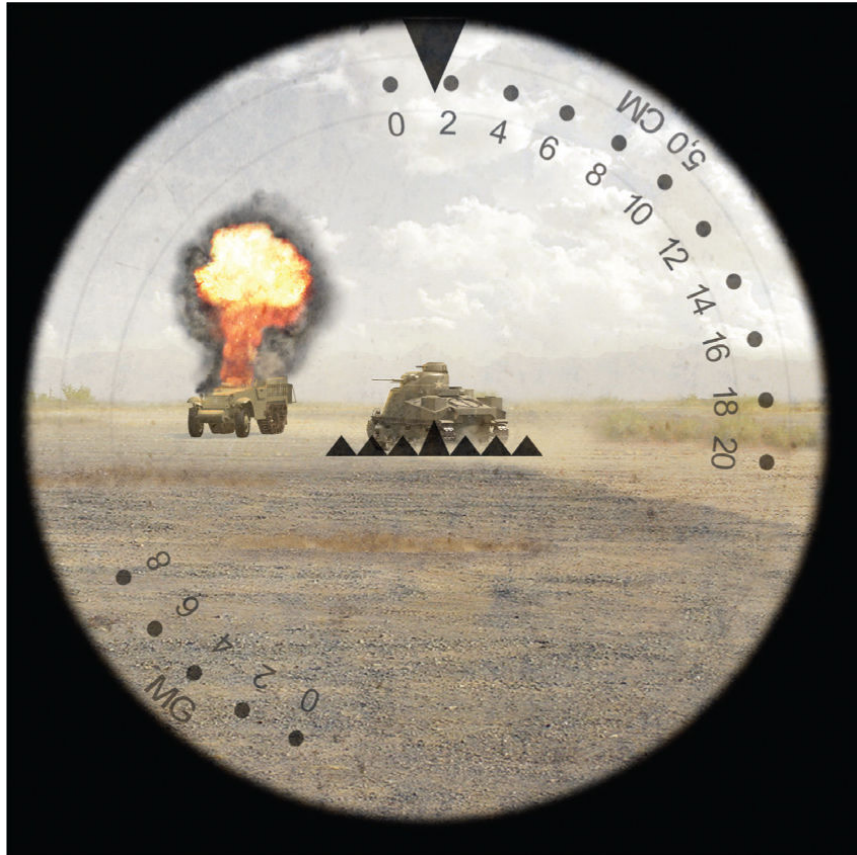
The round passes through the driver's compartment and explodes in the rear, igniting ammunition.

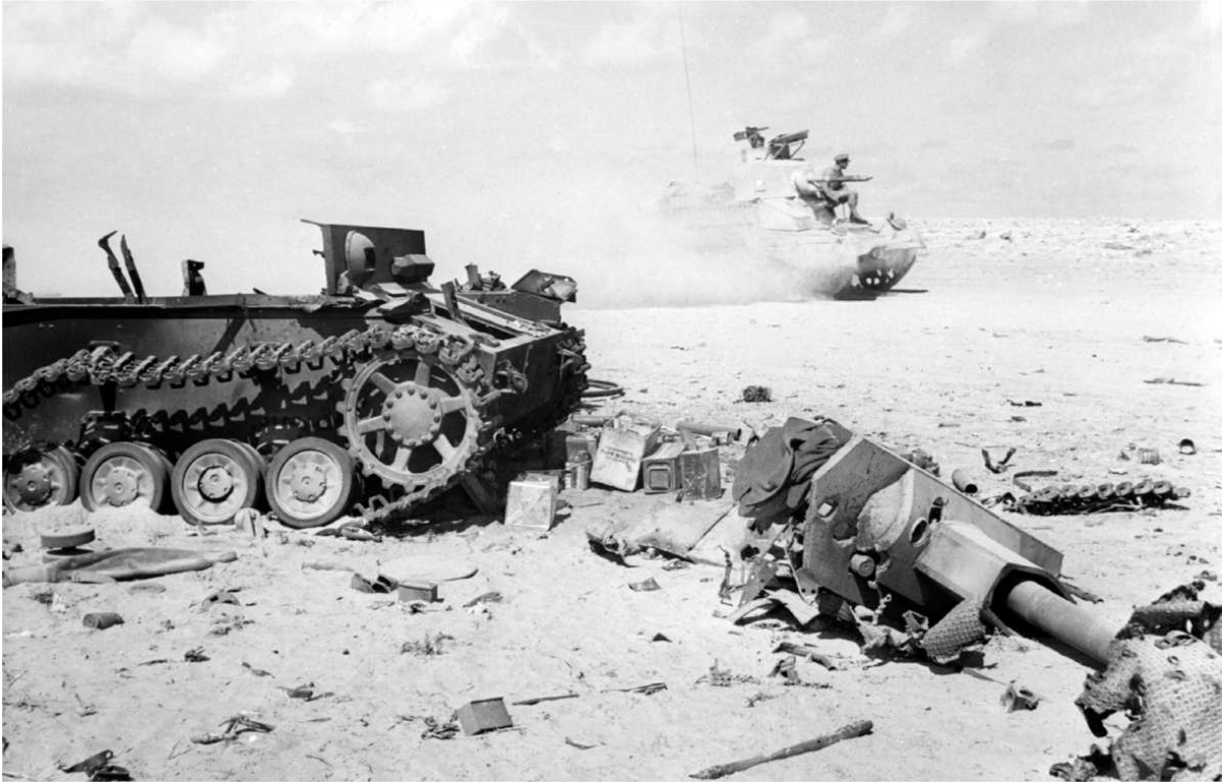
A British Stuart light tank passes the remains of a PzKpfw III that has been utterly obliterated by a catastrophic ammunition explosion, which has thrown the turret several metres away from the hull. (AirSeaLand/Cody)

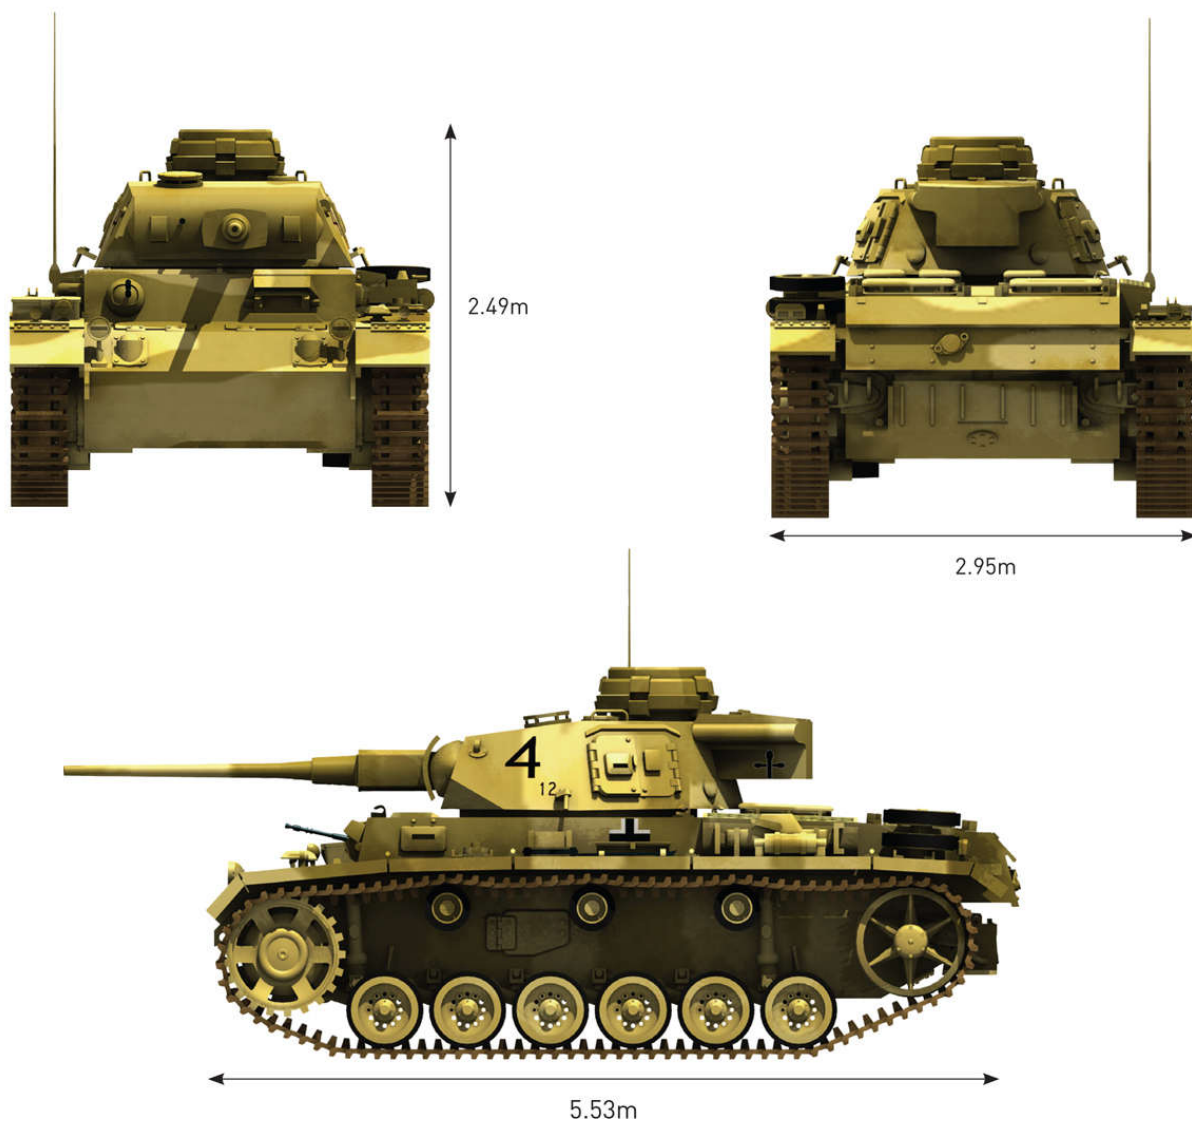
PZKPFW III

Panzer-Regiment 7 tanks were painted yellow-brown (RAL 8000), sometimes with the original dark grey (RAL 7027) showing through. Sometimes about 20 per cent of the tank was splotched with grey-green (RAL 7008). Sometimes continental-painted tanks were merely coated with used oil and dusted with sand. The company number was painted in black on the turret side, 4. Kompanie, with the tank number in smaller characters. The regimental insignia is seen on the equipment bin behind the turret. The *Balkenkreuz* (beamed cross) is on the hull and was often partly obscured by mud or lightly sprayed paint.

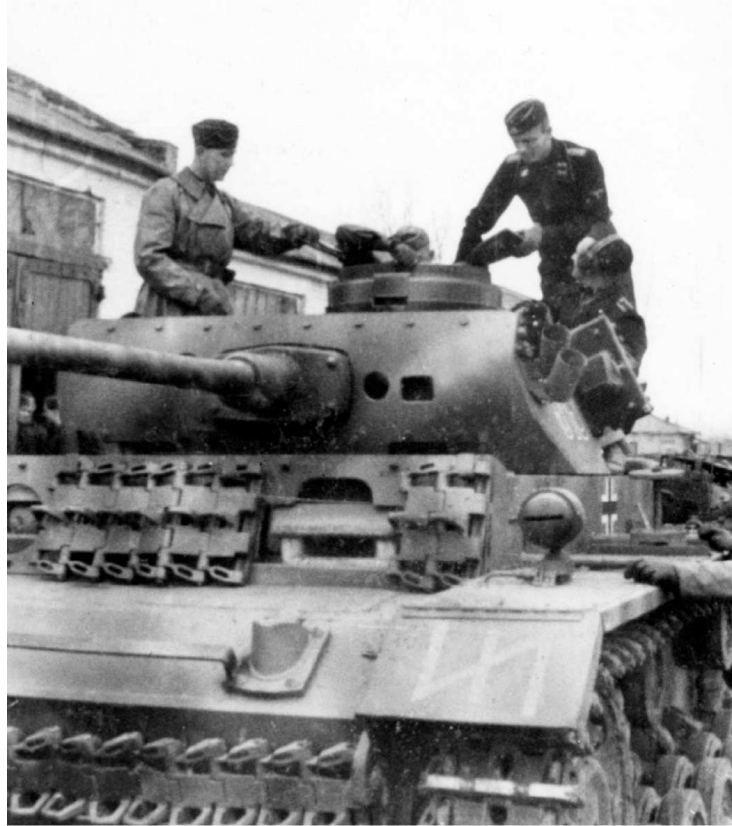
A PzKpfw III Ausf M is readied for action by its crew in Russia in 1943. Note the bank of smoke dischargers on the side of the turret, used to lay down a smokescreen either to shield an escape or obscure the vision of enemy gunners. (AirSeaLand/Cody)

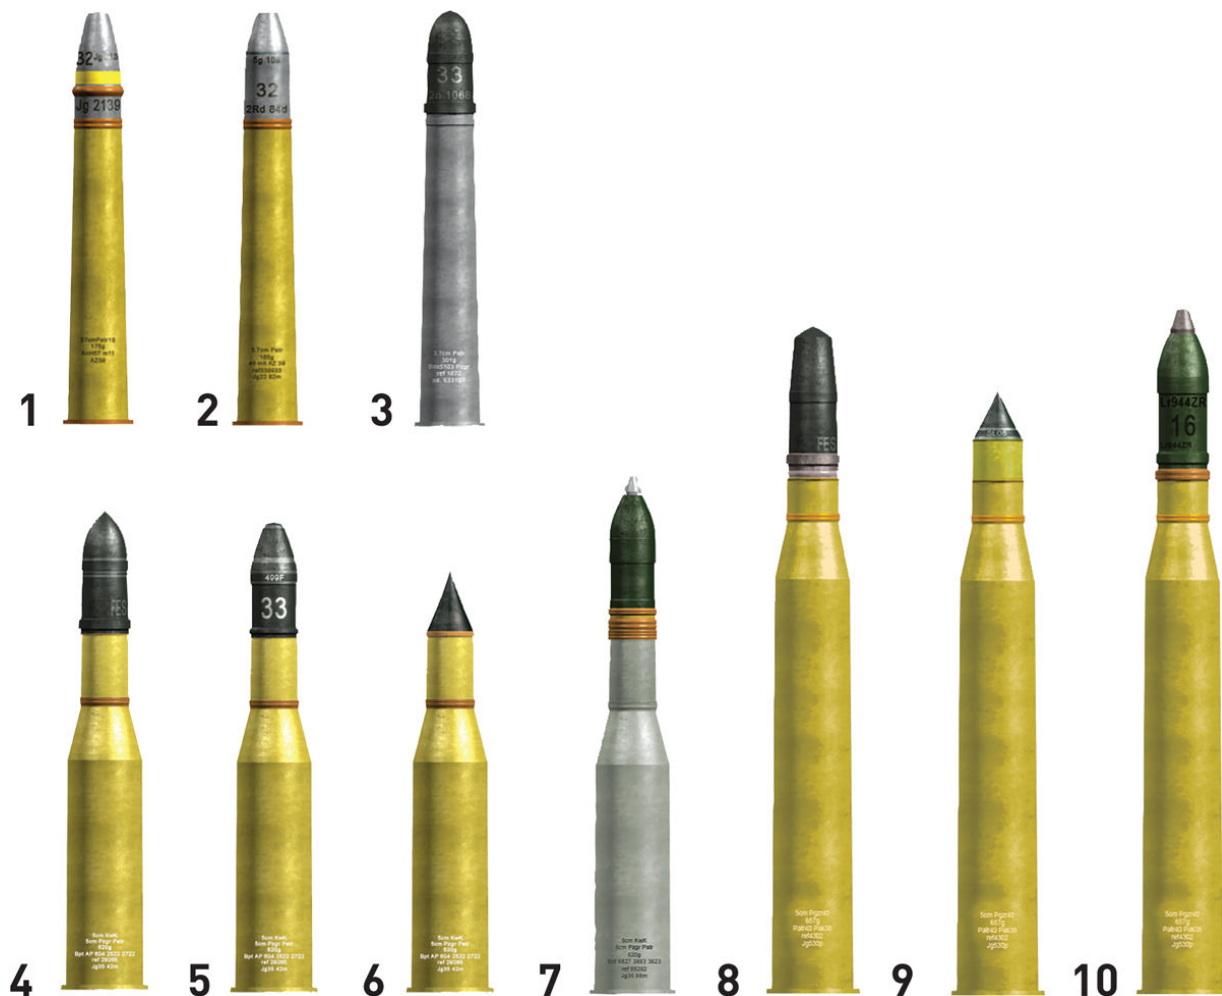
PZKPFW III AMMUNITION

1. 3.7cm Sprgr 18
2. 3.7cm Sprgr 40
3. 3.7cm Pzgr
4. 5cm Pzgr (KwK 38)
5. 5cm Pzgr 39 (KwK 38)
6. 5cm Pzgr 40 (KwK 38)
7. 5cm Sprgr 38 (KwK 38)
8. 5cm Pzgr 39 (KwK 39)
9. 5cm Pzgr 40 (KwK 39)

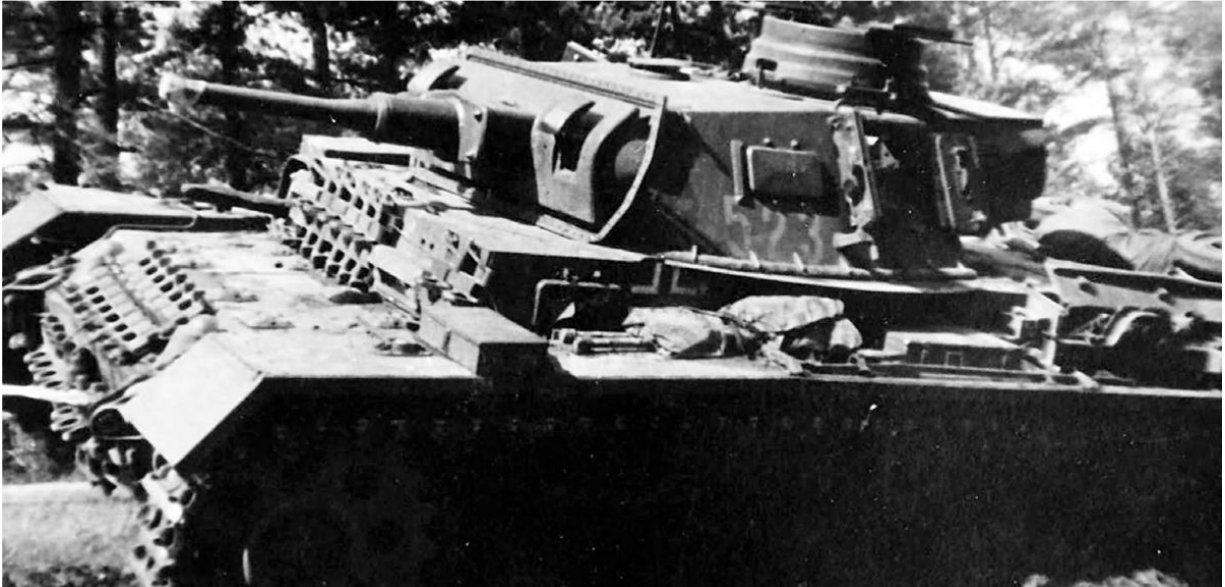
A version of the PzKpfw III capable of driving underwater, the Tauchpanzer (diving tank), was supplied with air via a snorkel hose and its hull was made completely waterproof by sealing all sighting ports, hatches and air intakes. (AirSeaLand/Cody)

The intention was for the tanks to launch themselves from lighters and then motor ashore along the seabed, direction being maintained by instructions passed through a radio link from the parent vessel. The design was, on the whole, successful and found a practical application at the crossing of the River Bug during Operation *Barbarossa*. The crews were drawn from volunteer battalions, which were later formed into Panzer-Regiment 18.

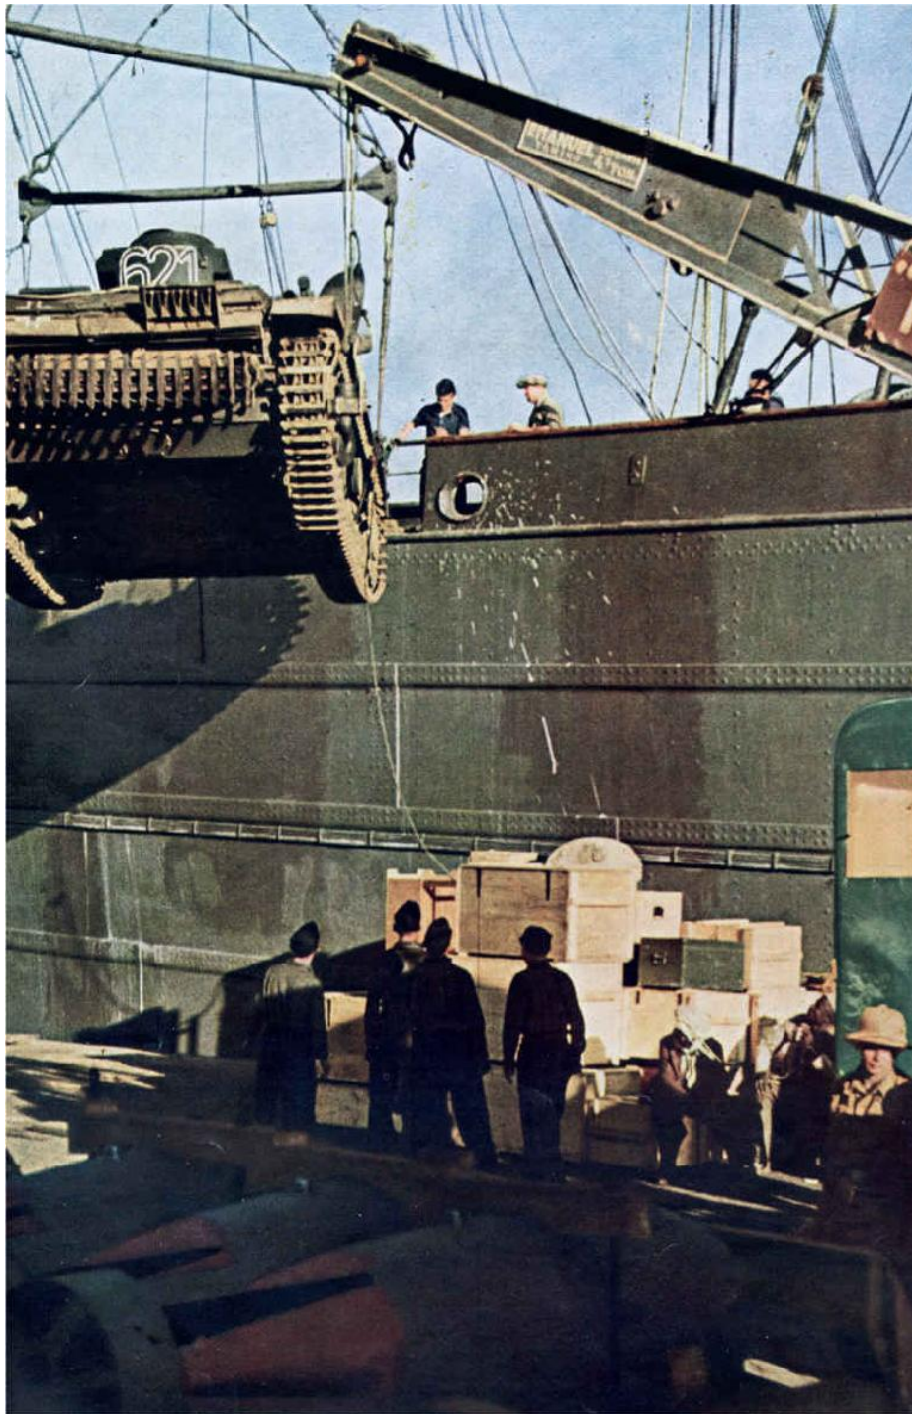
A PzKpfw III is loaded onto a merchant ship for transportation to the North African theatre. The three-digit numbering system worked as follows: the first digit designated the company, the second the platoon and the third the specific tank. (AirSeaLand/Cody)
